**Third Five-Year Review Report
for
Agrico Chemical Company
FLD980221857**

**Pensacola
Escambia County, Florida**

June 2010

Prepared By:
E² Inc.
Charlottesville, Virginia
2417 Northfield Road
Charlottesville, VA
22902

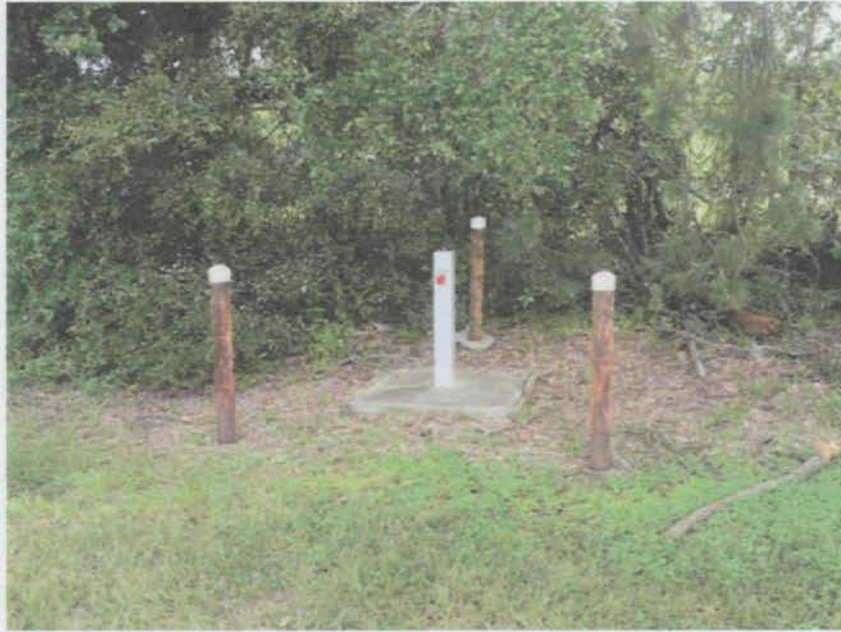
Monitoring well AC-7SR, located on the eastern edge of OU1.

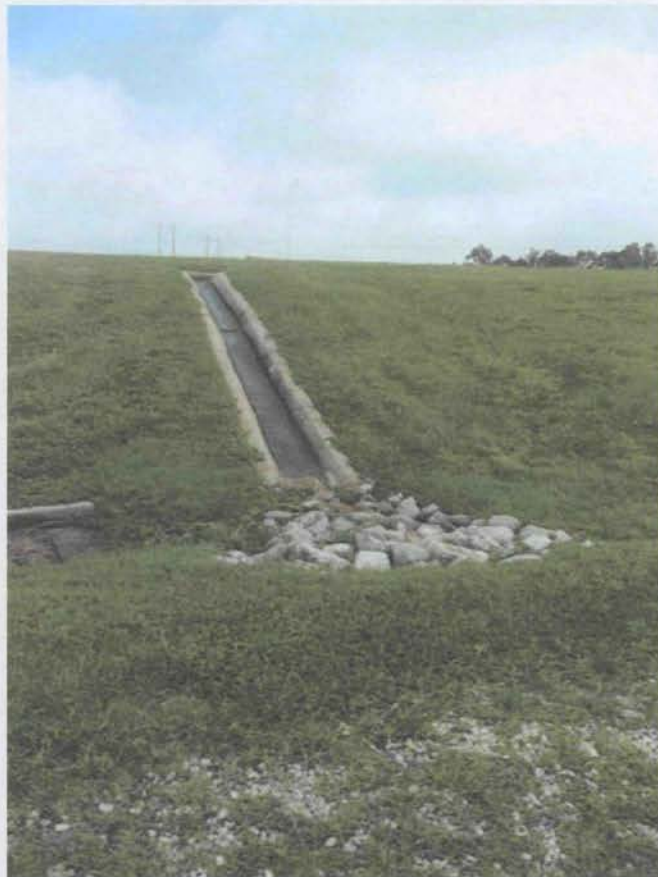
Water drainage area to prevent erosion of the RCRA cap.

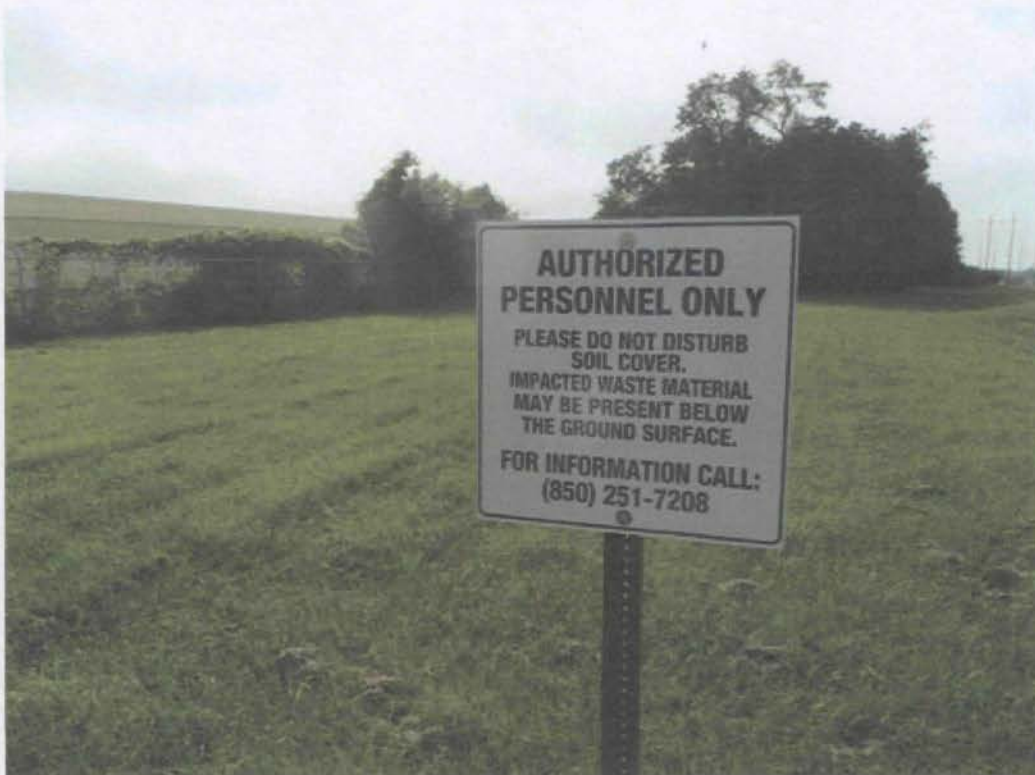
Sign posted at the Site's entrance gates to prevent trespassing.

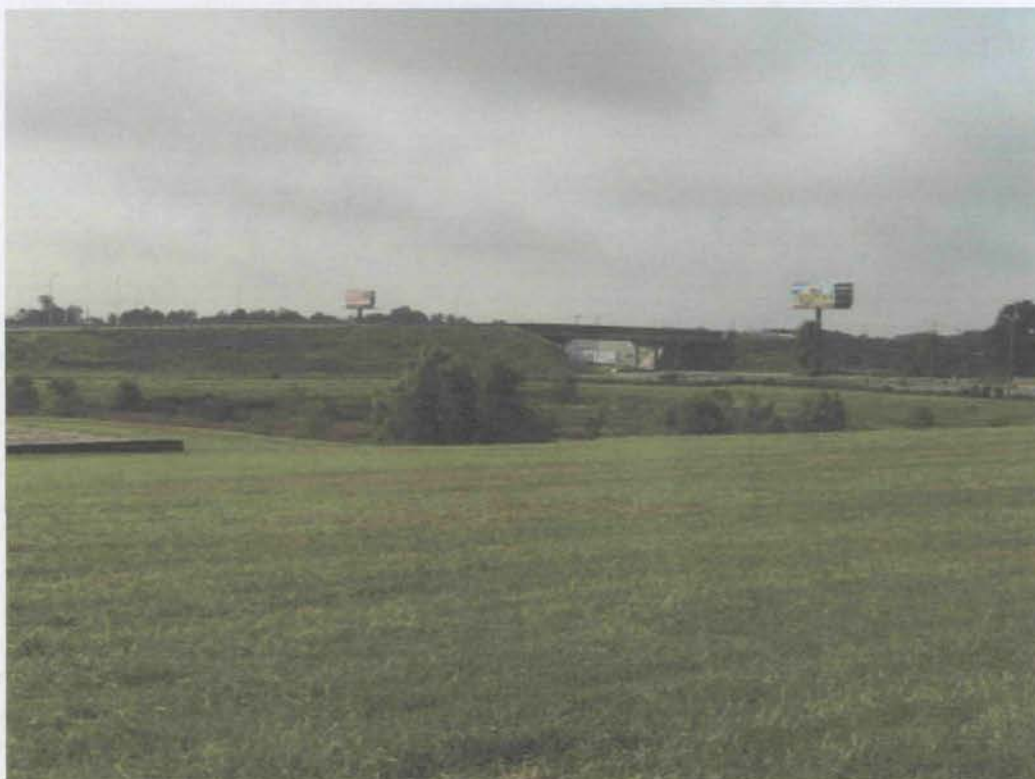
View of the south stormwater pond at the Site.

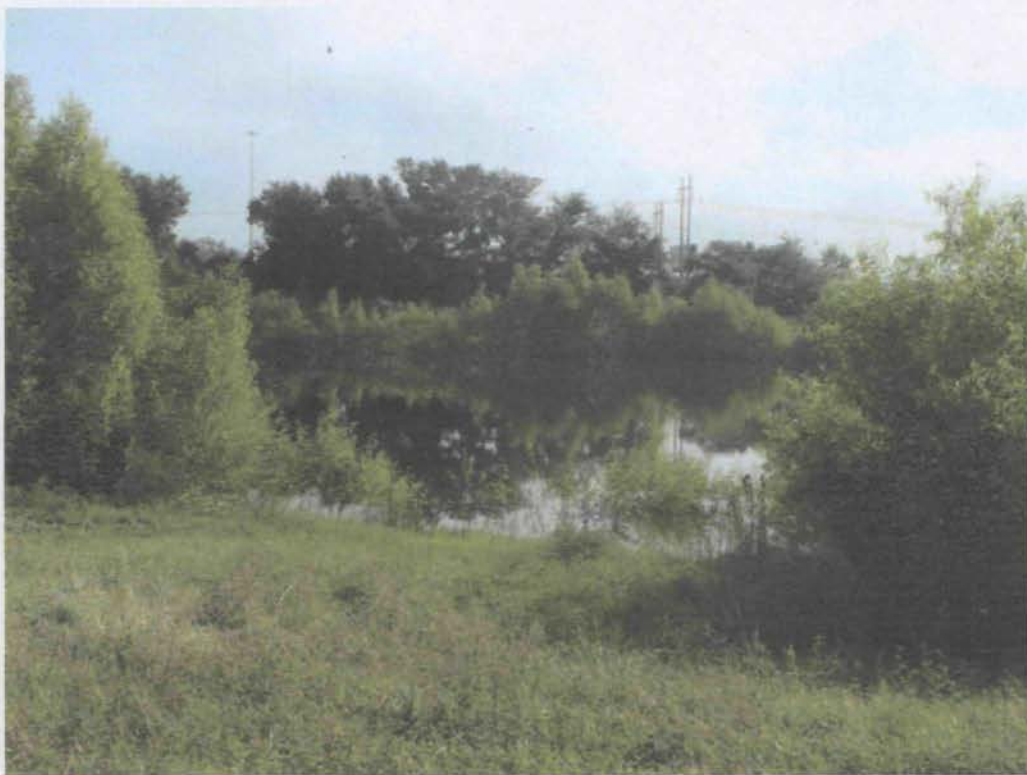
View of the north stormwater pond at the Site.

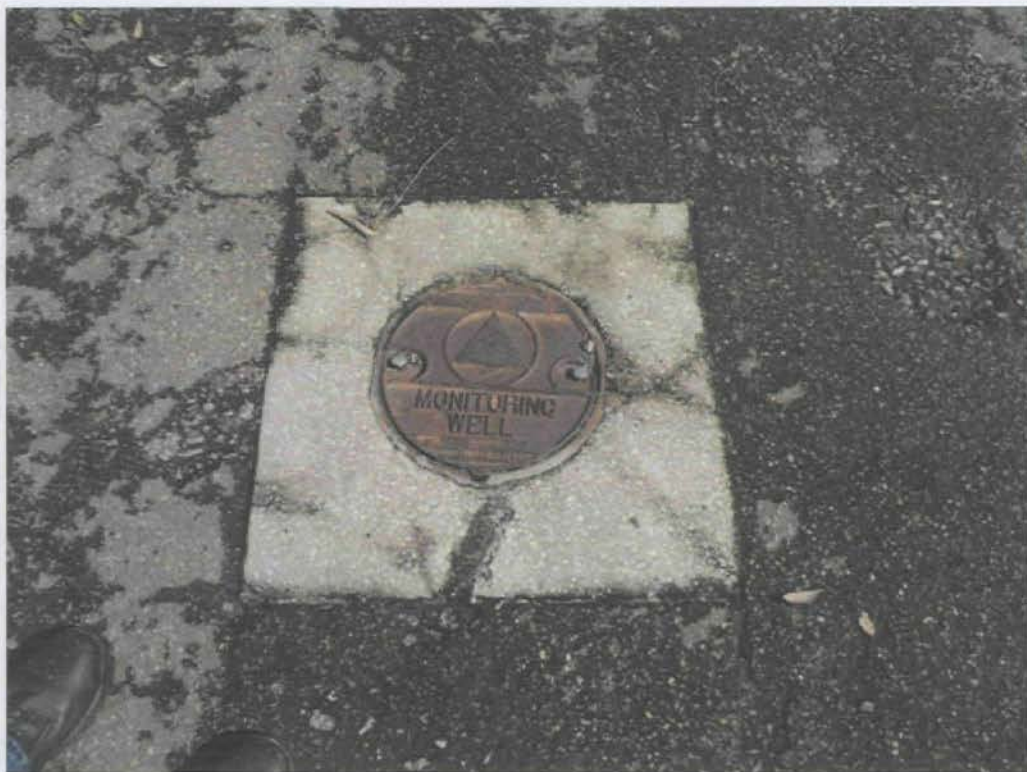
Monitoring well AC-35D, located at the edge of Bayou Texar.

EPA recommends, however, that if the levels of fluoride in monitoring well AC-35D, which is closest to Bayou Texar, increase to concentrations that are significantly above what have been measured over the last ten years of groundwater monitoring, that the responsible parties must submit a work plan to evaluate whether this increase in groundwater concentration will result in an area-weighted average fluoride concentration in pore water greater than the regulatory limit of 5 mg/L standard in the bioactive zone of the sediment. This work plan also will recommend further risk evaluation studies should it be concluded, as a result of sampling, that pore water concentrations of fluoride in the bioactive zone are greater than the 5 mg/L Class III Marine waters fluoride standard on an area-weighted basis.

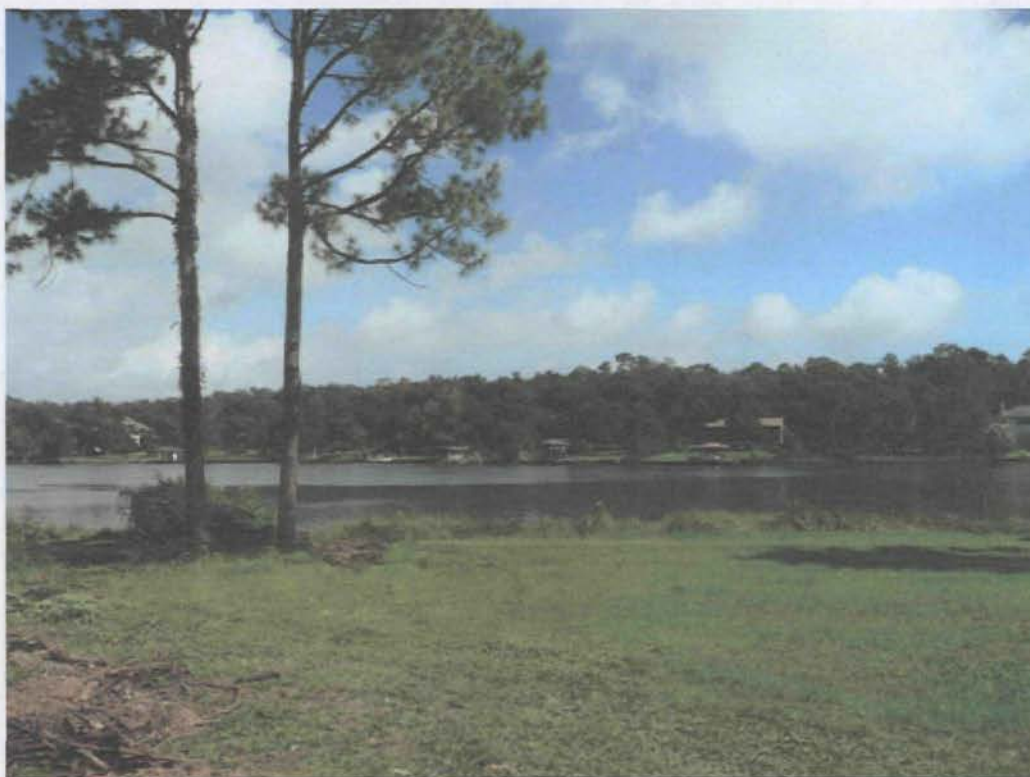
View of area where surface water samples were taken at Bayou Texar.
