FIVE-YEAR REVIEW REPORT (2010-2015) Fourth Five-Year Review for Agrico Chemical Company FLD980221857 Pensacola, Escambia County, Florida

Fourth Five-Year Review Report for Former Agrico Chemical Company 118 E. Fairfield Drive at Interstate 110 Pensacola Escambia County, Florida

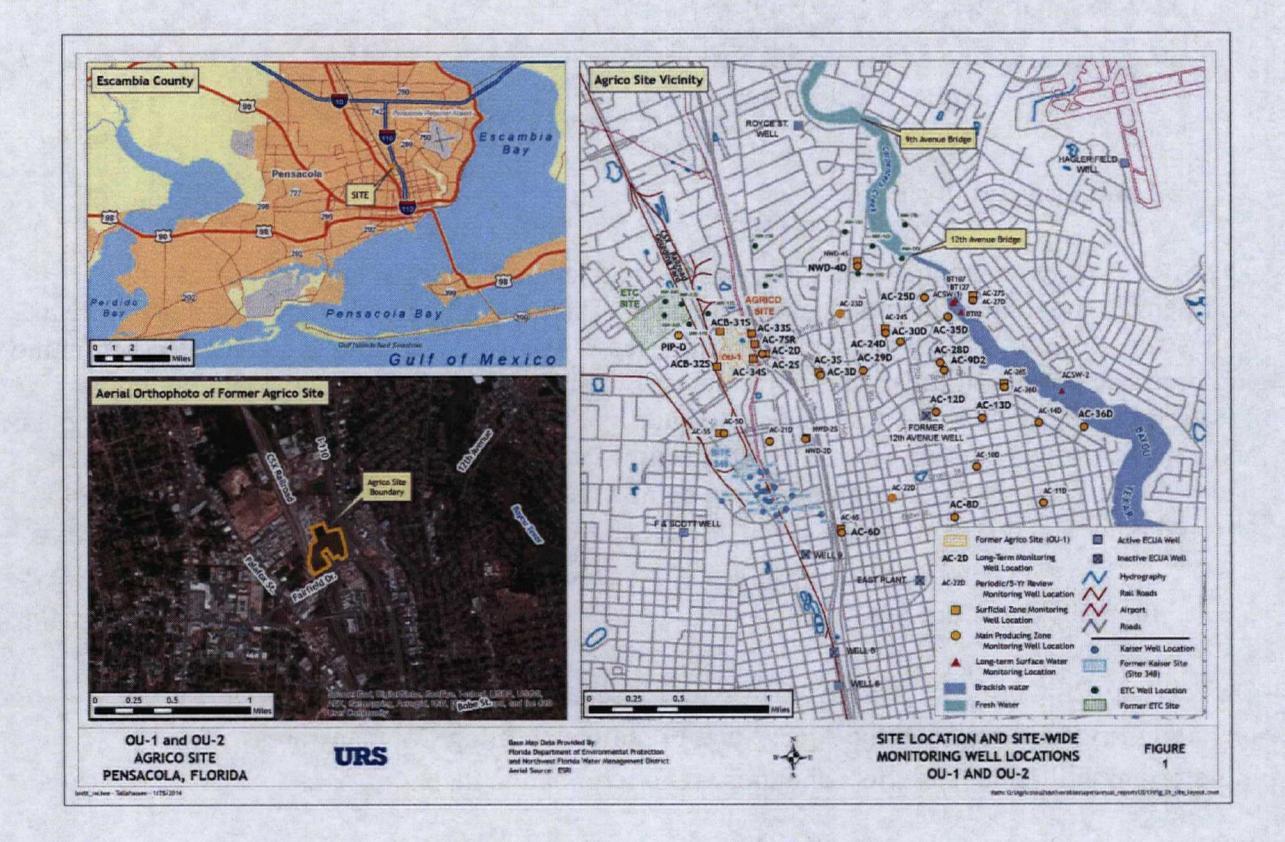
Figure 1 -	Site Location and Site-Wide Monitoring Well Locations OU-1 and OU-21	0
Figure 2 -	OU-1 Site Area and Monitoring Well Location1	1
